VUF-1015
FINAL REPORT

VELA UNIFORM PROJECT SHOAL

PRESHOT AND POSTSHOT STRUCTURE SURVEY
Holmes & Narver, Inc.

December 1963

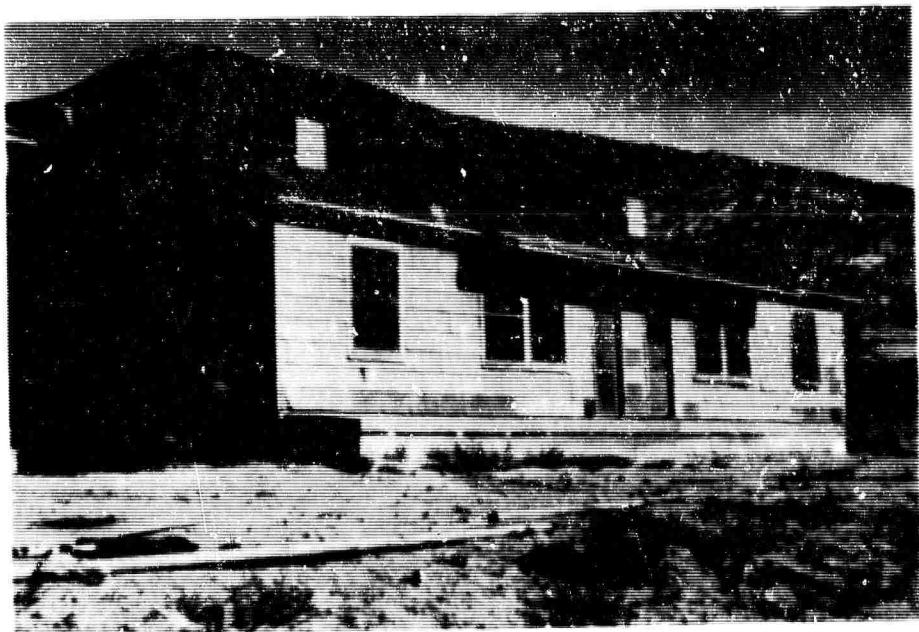
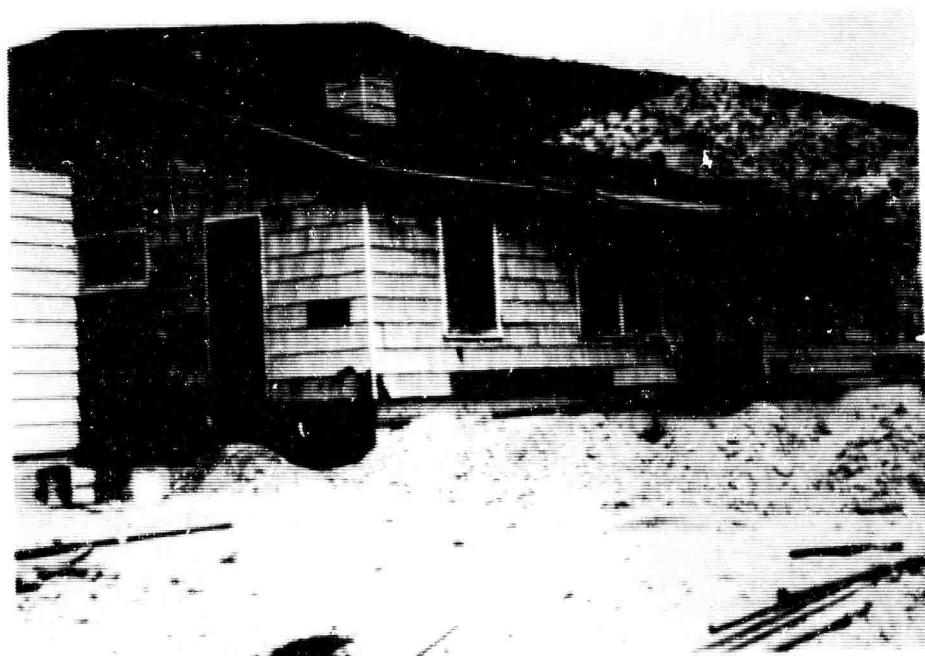
Photo No. 21-3 - Preshot - October 8, 1963

21-3 Residence (See photo 21-3) This structure is wood frame, asbestos shingle covered. Size is 27 x 55 feet. AZ 295° clockwise from magnetic north. This structure has been recently moved to this site, and is in the process of being renewed inside and out. No damage was noted as a result of the postshot survey.

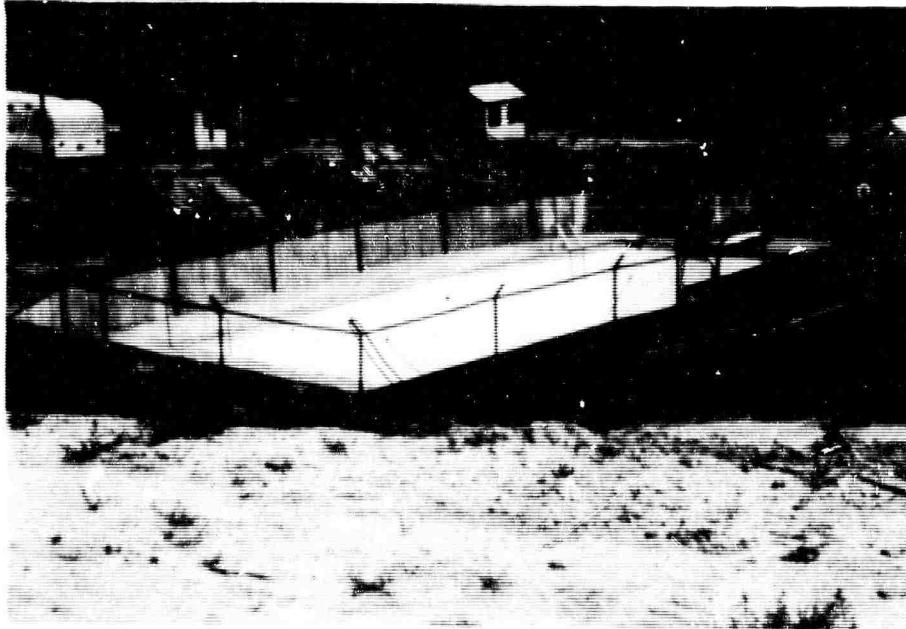
Photo No. 21-4 - Preshot - October 2, 1963

21-4 Swimming Pool (See photo 21-4) This structure is a concrete swimming pool with a chain link fence around it AZ 130° clockwise from magnetic north. Size 20 x 50 feet. No damage was noted as a result of the postshot survey.

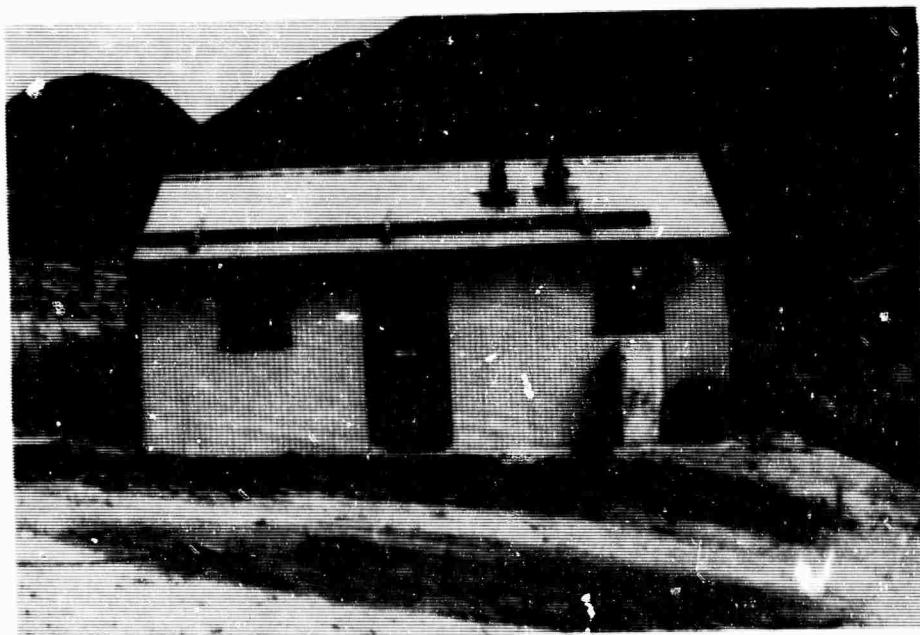
Photo No. 21-5 Preshot - October 2, 1963

21-5 Bath House (See photo 21-5) This structure is a wood frame and corrugated-metal-covered bath house. Size about 12 x 22 feet. AZ 40° clockwise from magnetic north. No damage was noted as a result of the postshot survey.

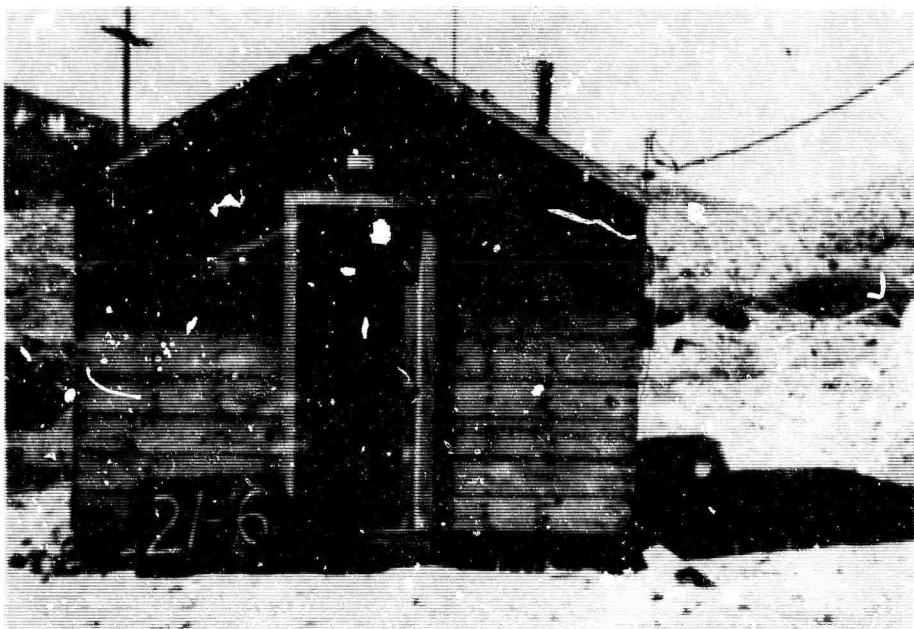
Photo No. 21-6 - Preshot - October 2, 1963

21-6 Shack (See photo 21-6) This is a wood frame, wood-covered shack, about 10 x 12 feet. AZ 225° clockwise from magnetic north. The structure is unpainted and weathered and the glass in the door is broken. No damage was noted as a result of the postshot survey.

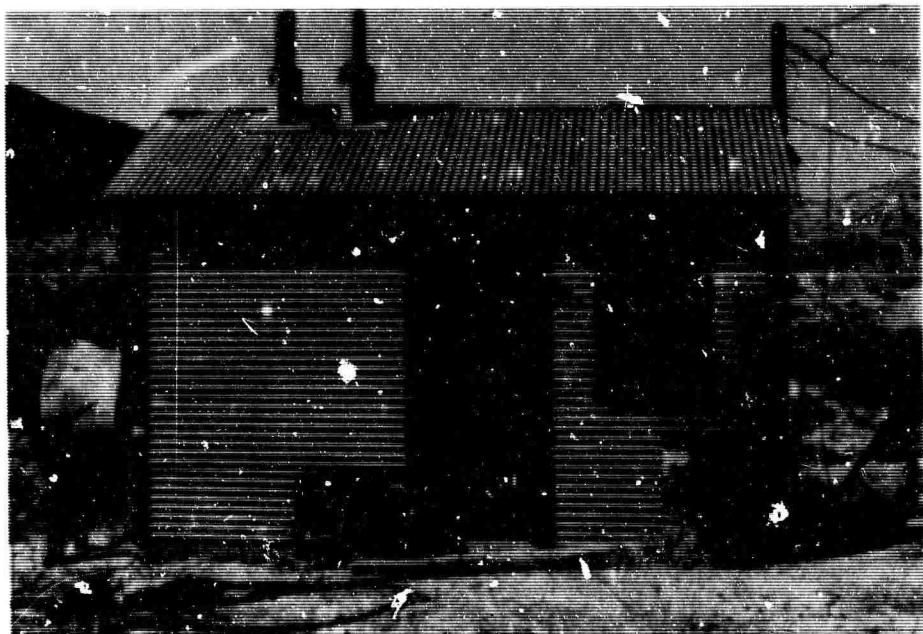
Photo No. 21-7 - Preshot - October 2, 1963

21-7 Bath House (See photo 21-7) This structure is a 9 x 15-foot wood frame and corrugated-metal-covered bath house for women. AZ 225° clockwise from magnetic north. No damage was noted as a result of the postshot survey.

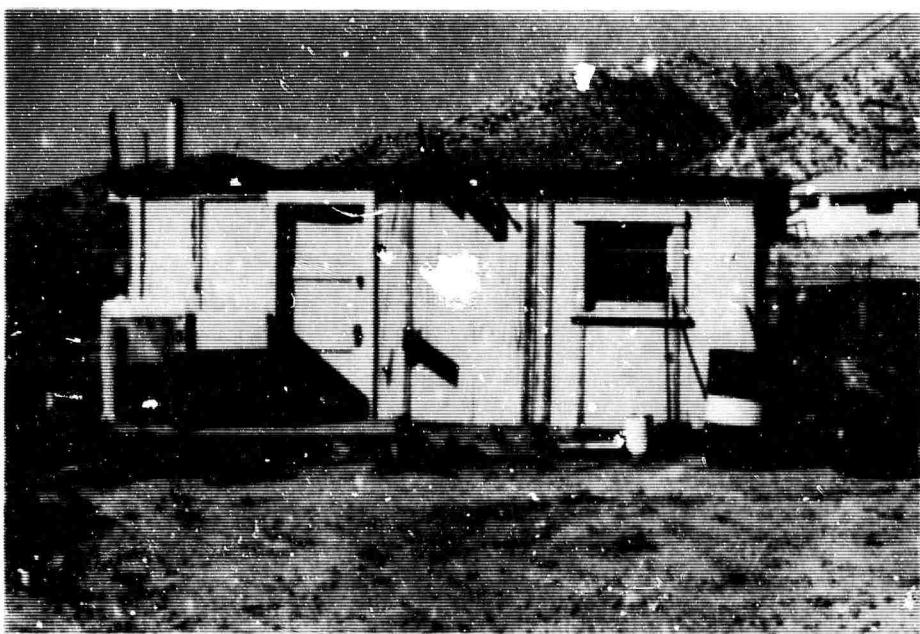
Photo No. 21-8 - Preshot - October 2, 1963

21-8 Shack (See photo 21-8) This is an 8 x 15-foot wood shack. AZ 250° clockwise from magnetic north. Flywood siding is weathered and checked. No damage was noted as a result of the postshot survey.

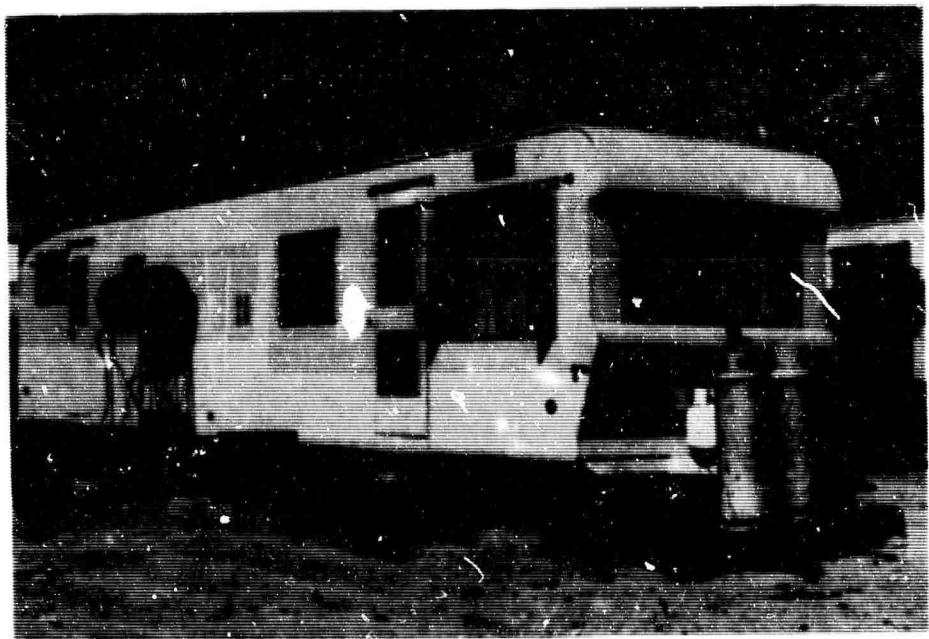
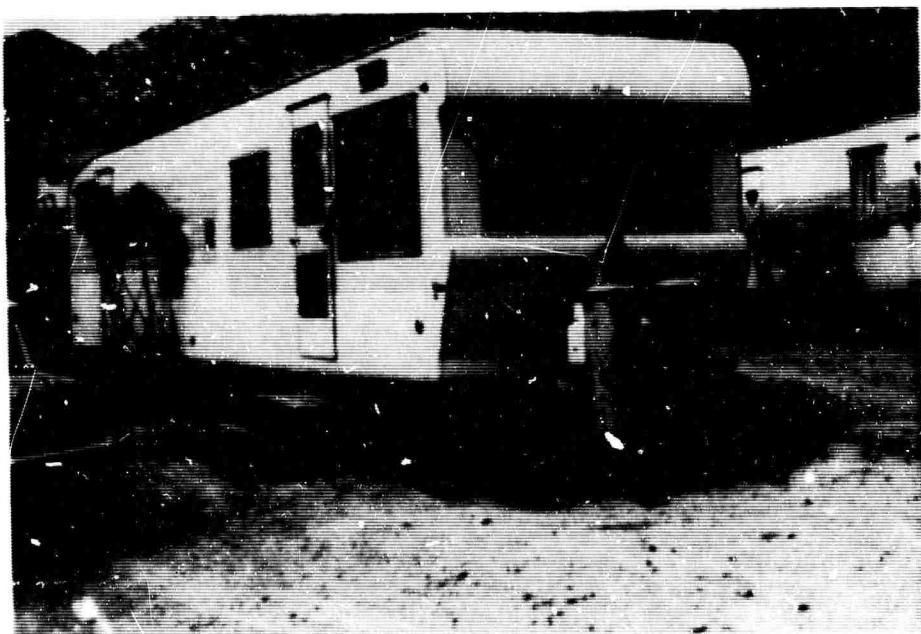
Photo No. 21-9 - Preshot - October 2, 1963

21-9 Trailer (See photo 21-9) This is a 36-foot long by 8-foot wide metal covered trailer. AZ 227° clockwise from magnetic north. No damage was noted as a result of the postshot survey.

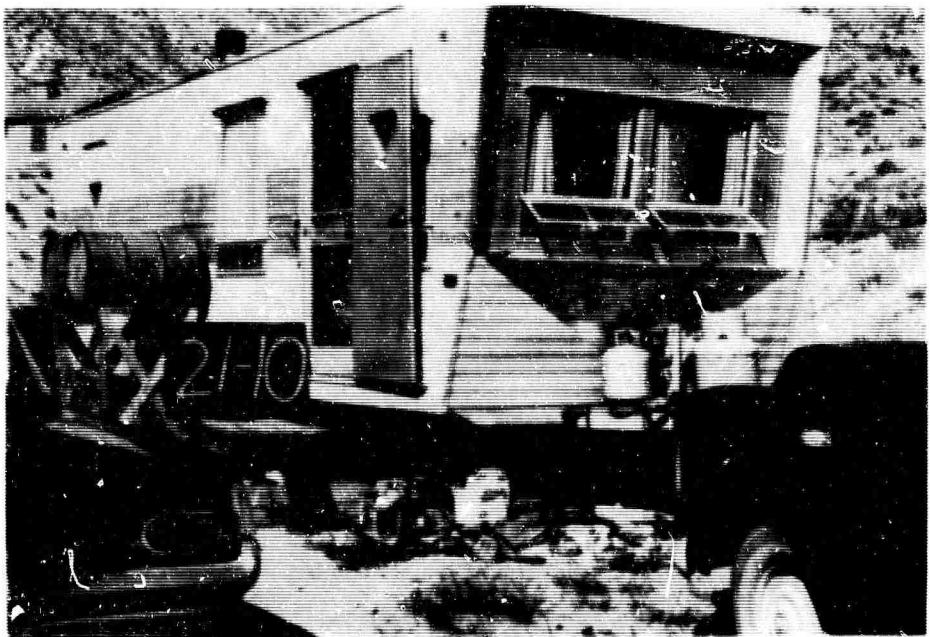
Photo No. 21-10 - Preshot - October 2, 1963

21-10 Trailer (See photo 21-10) This is a 24-foot long by 8-foot wide metal-covered trailer. AZ 227° clockwise from magnetic north. No damage was noted as a result of the postshot survey.

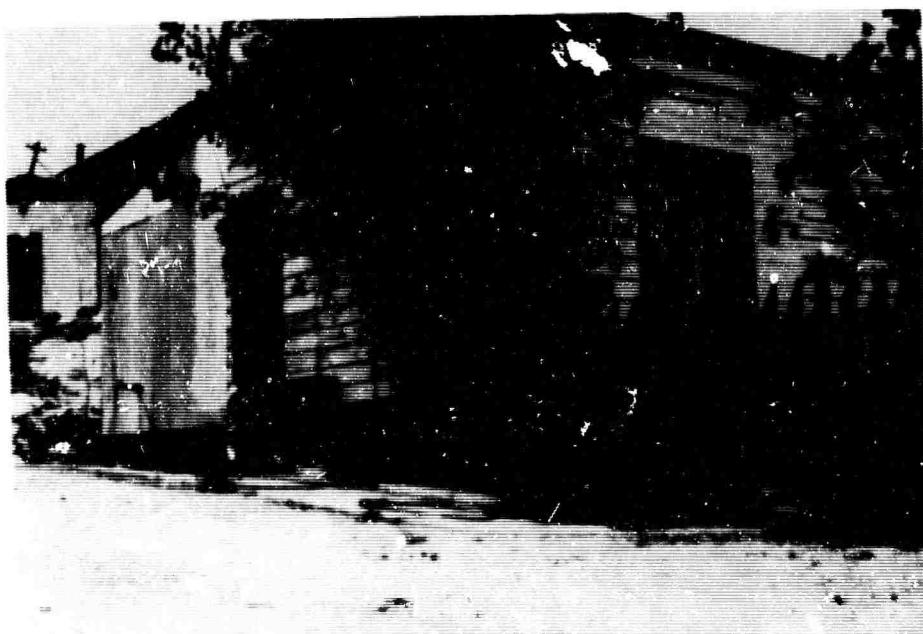
Photo No. 21-11 - Preshot - October 2, 1963

21-11 Residence (See photo 21-11) This structure is a residence of wood frame with partly wood siding and partly corrugated metal covering. The size of the structure is 27 x 42 feet. AZ 35° clockwise from magnetic north. No damage was noted as a result of the postshot survey.

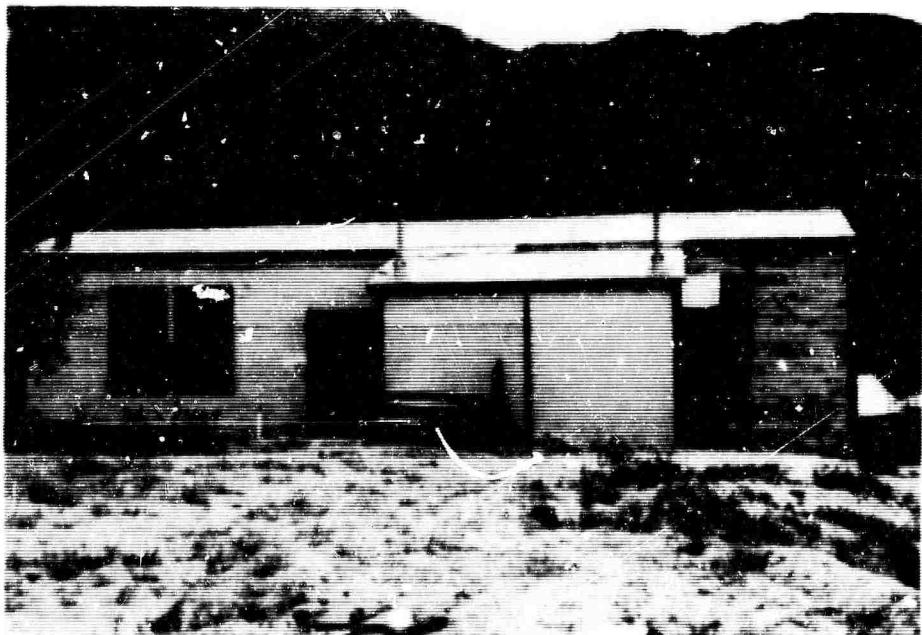
Photo No. 21-12 - Preshot - October 2, 1963

21-12 Residence (See photo 21-12) This structure is a 27 x 42-foot residence of wood frame with part wood siding and the rest covered with corrugated metal. AZ 80° clockwise from magnetic north. No damage was noted as a result of the post-shot survey.

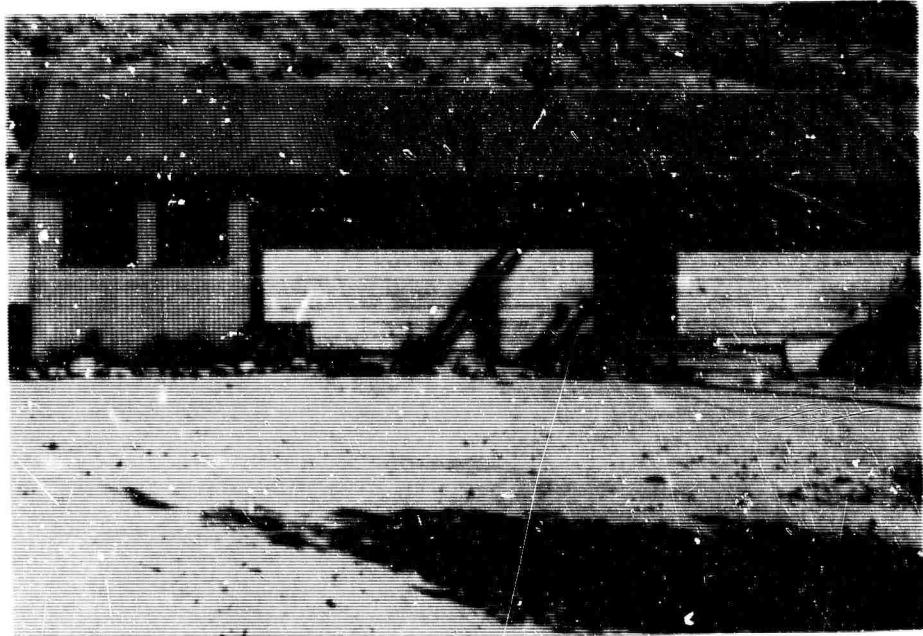
Photo No. 21-13 - Preshot - October 2, 1963

21-13 School House and Residence (See photo 21-13) This structure is a combined school house and residence of wood frame with part wood siding and the rest covered with corrugated metal. Roof is corrugated metal. It is 27 x 36 feet. AZ is 0° from magnetic north. No damage was noted as a result of the post-shot survey.

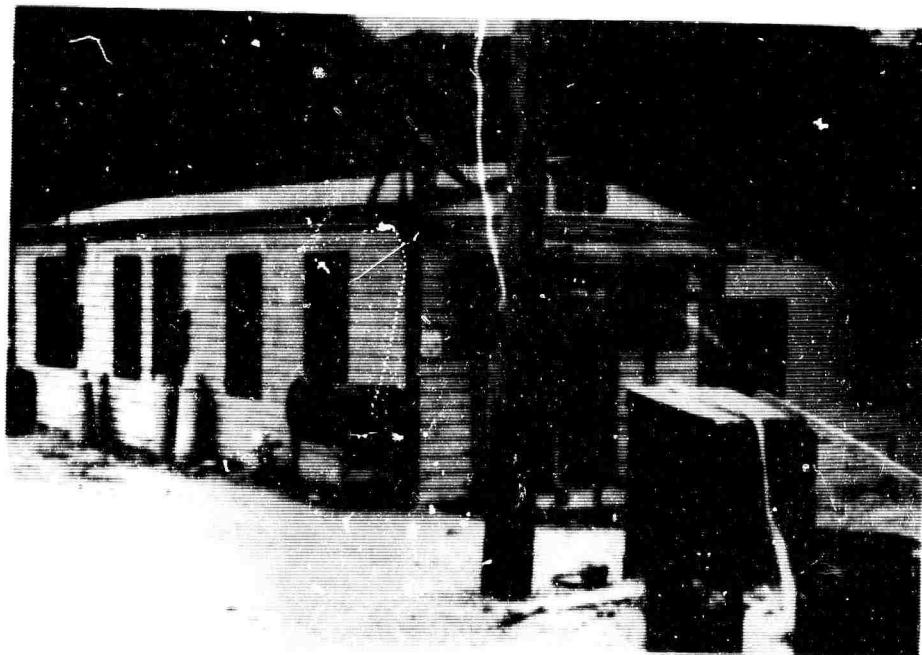
Photo No. 21-14 - Preshot - October 2, 1963

21-14 Residence (See photo 21-14) A residential wood frame structure covered partly with wood siding and partly with corrugated metal. Dimensions are 36 x 42 feet. Roof is corrugated metal. AZ is 70° clockwise from magnetic north. No damage was noted as a result of the postshot survey.

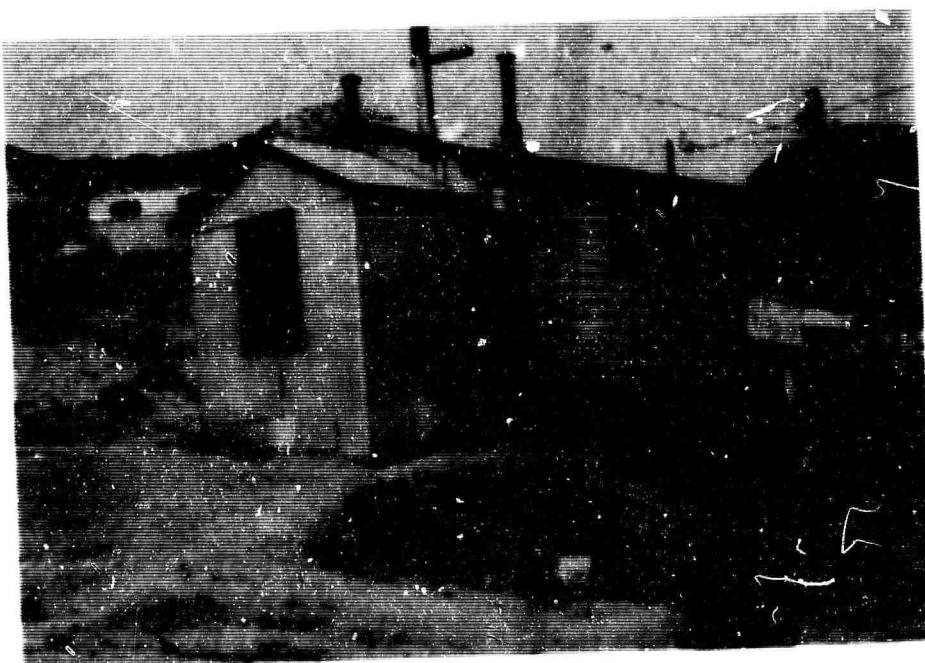
Photo No. 21-15 - Preshot - October 2, 1963

21-15 Bath House (See photo 21-15) Bath house structure, 9 x 24 feet, of wood frame and wood siding with some corrugated metal covering. AZ 330° clockwise from magnetic north. No damage was noted as a result of the postshot survey.

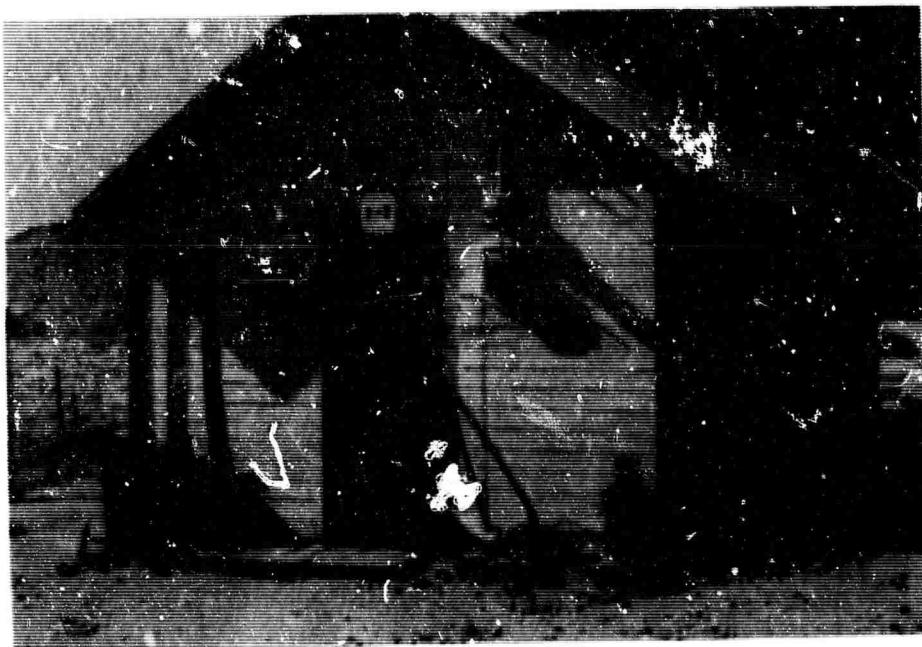
Photo No. 21-19 - Preshot - October 2, 1963

21-19 Residence (See photo 21-19) This is a 12 x 24-foot residence of wood frame and wood siding. AZ 220° clockwise from magnetic north. No damage was noted as a result of the postshot survey.

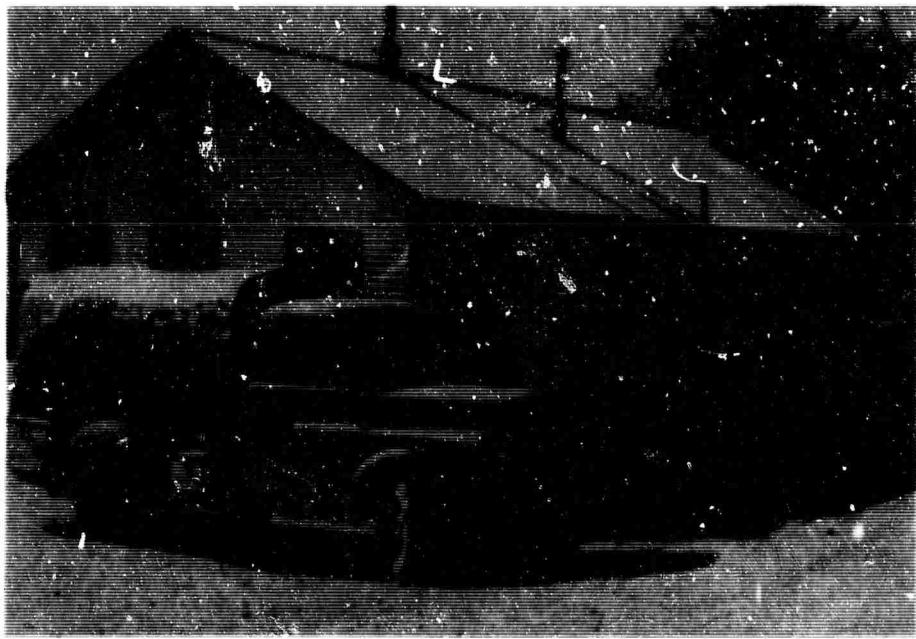
Photo No. 21-22 - Preshot - October 2, 1963

21-22 Residence (See photo 21-22) This is an 18 x 27-foot residential structure of wood frame and corrugated metal siding. AZ 220° clockwise from magnetic north. No damage was noted as a result of the postshot survey.

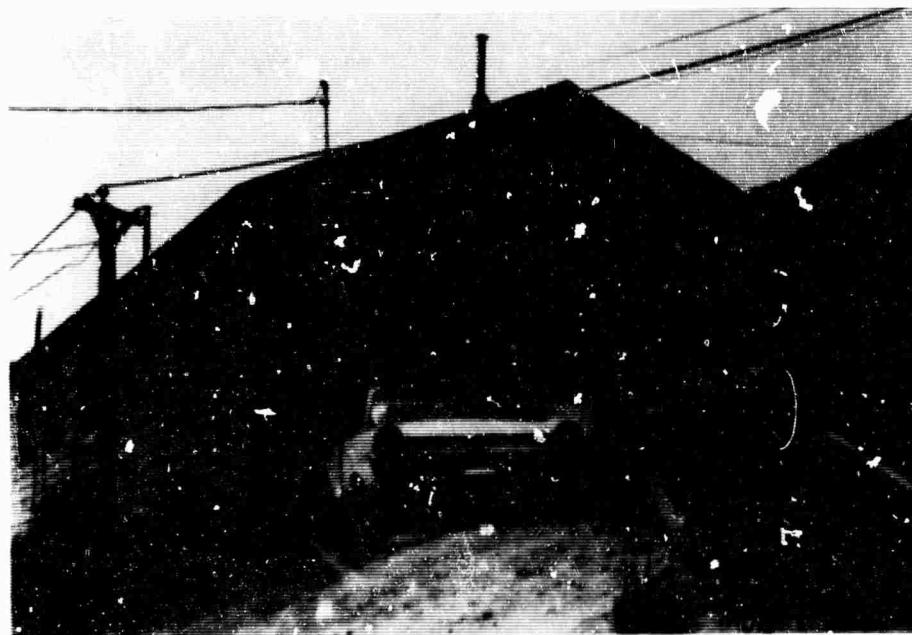
Photo No. 21-25 - Preshot - October 2, 1963

21-25 Bunkhouse (See photo 21-25) This is a 24 x 45-foot bunkhouse of wood frame and wood siding. AZ 250° clockwise from magnetic north. No damage was noted as a result of the postshot survey.

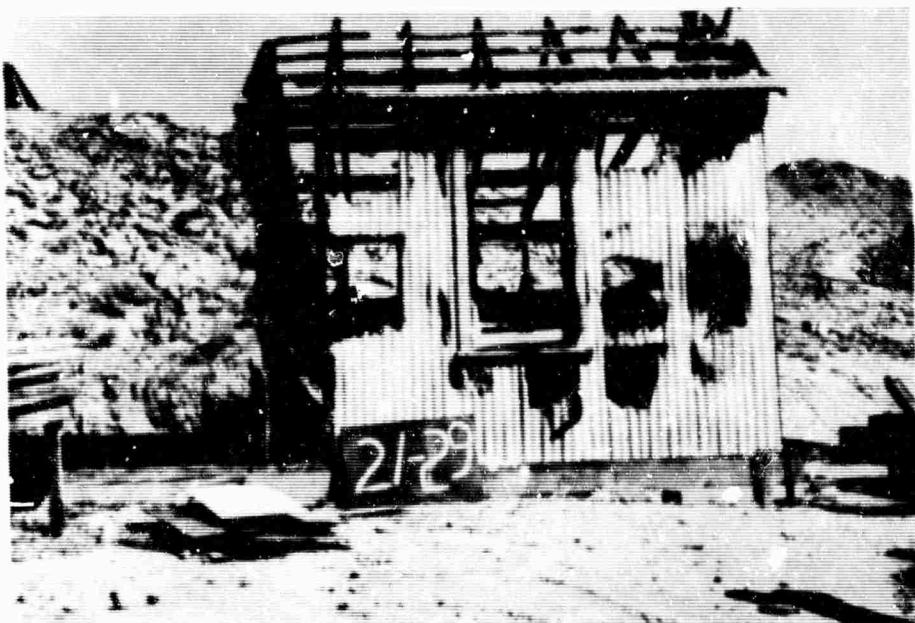
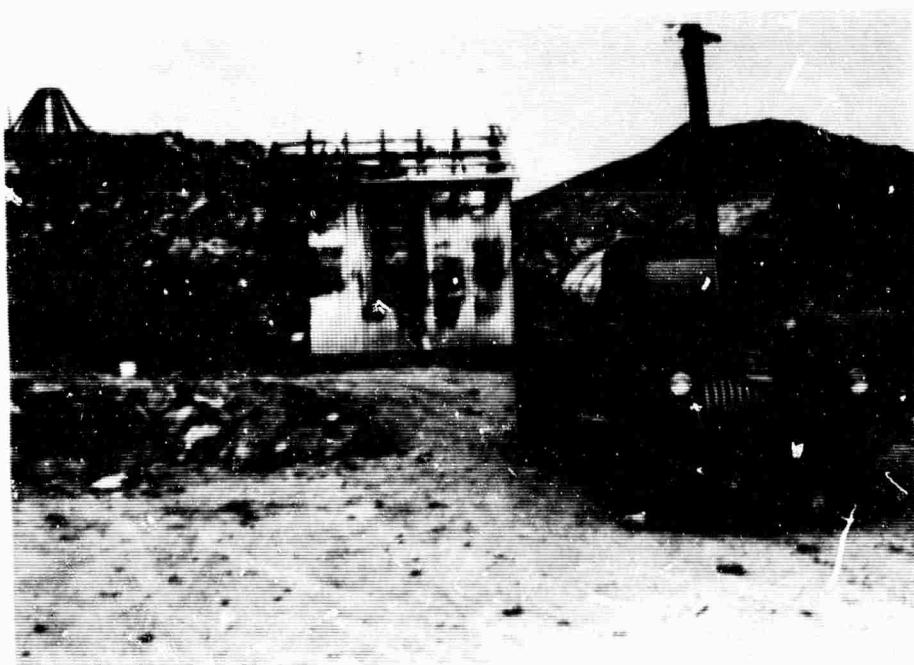
Photo No. 21-29 - Preshot - October 2, 1963

21-29 Shed (See photo 21-29) Photo shows a 12 x 12-foot burned-out shed. AZ 345° clockwise from magnetic north. It was assumed that this structure would be removed before the shot date; however, it was still in place after the shot. No damage was noted as a result of the postshot survey.

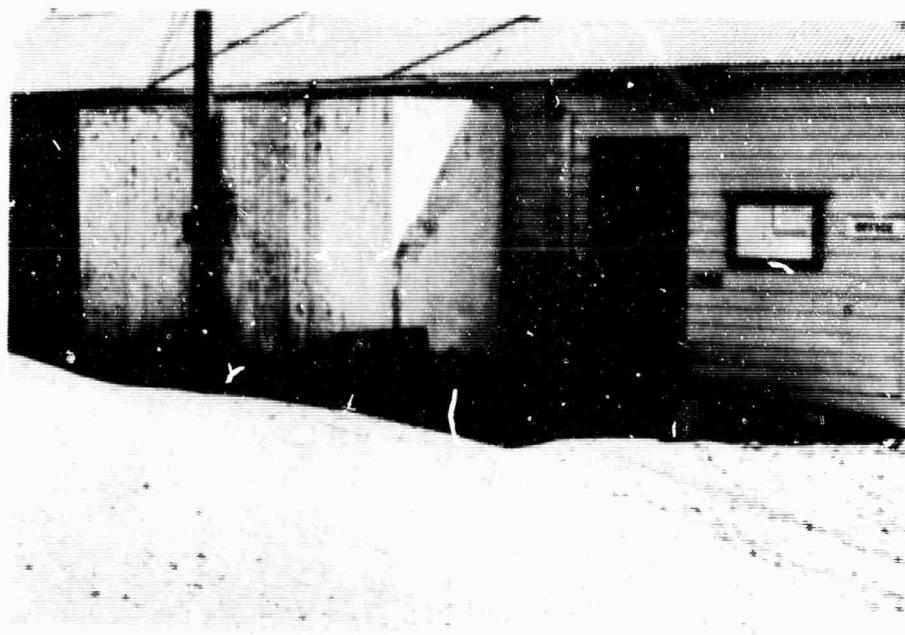
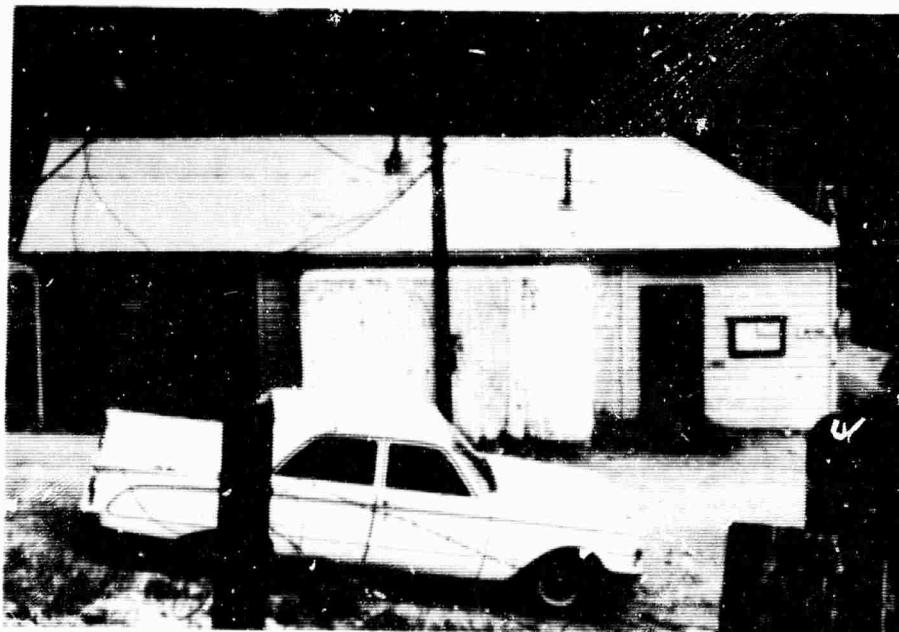
Photo No. 21-30 - Preshot - October 2, 1963

21-30 Office (See photo 21-30) This is a 20 x 40-foot office building of wood frame and wood siding. AZ 80° clockwise from magnetic north. No damage was noted as a result of the postshot survey.

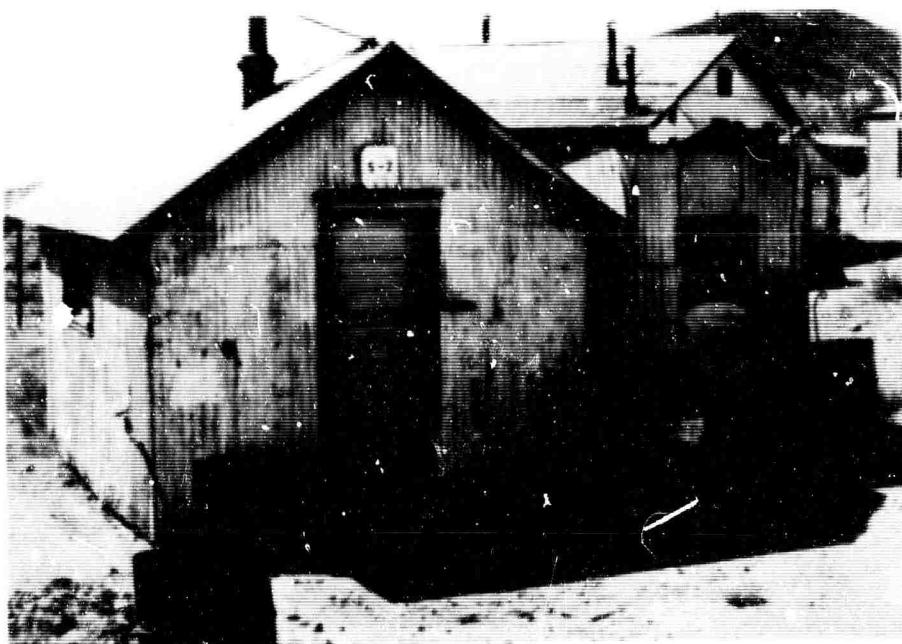
Photo No. 21-33 - Preshot - October 2, 1963

21-33 Store Room (See photo 21-33) This is a 12 x 15-foot wood frame with corrugated metal siding store room structure. AZ 150° clockwise from magnetic north. No damage was noted as a result of the postshot survey.

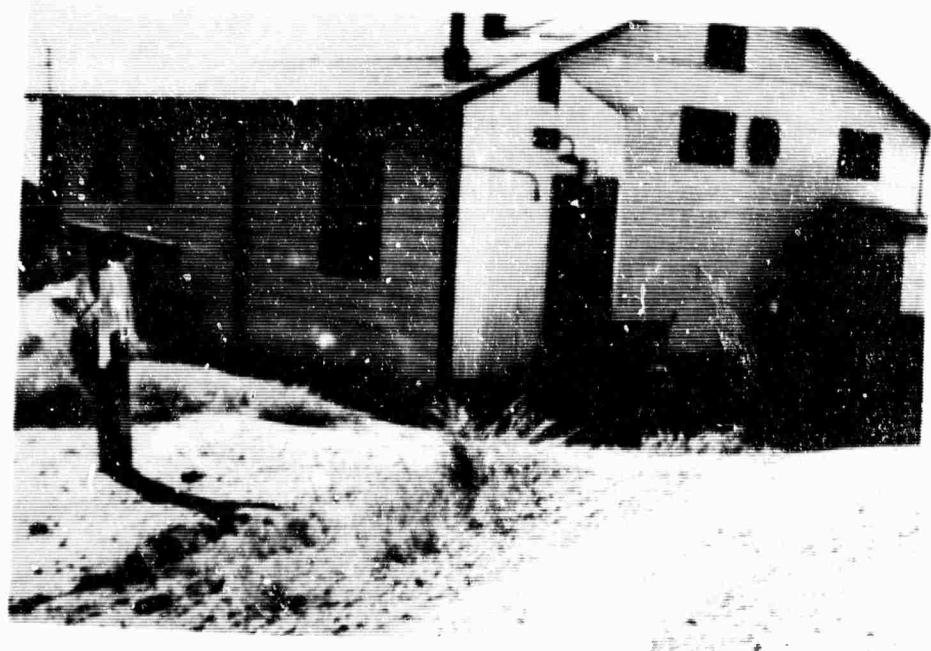
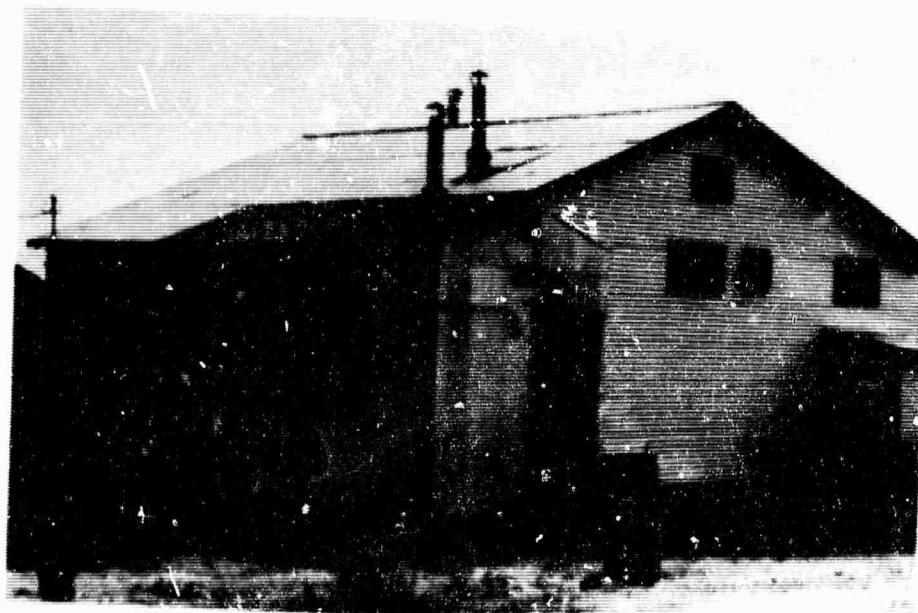
Photo No. 21-34 - Preshot - October 2, 1963

21-34 Change Room (See photo 21-34) Change room structure, 30 x 30 feet, of wood frame and corrugated metal siding. AZ 130° clockwise from magnetic north. No damage was noted as a result of the postshot survey.

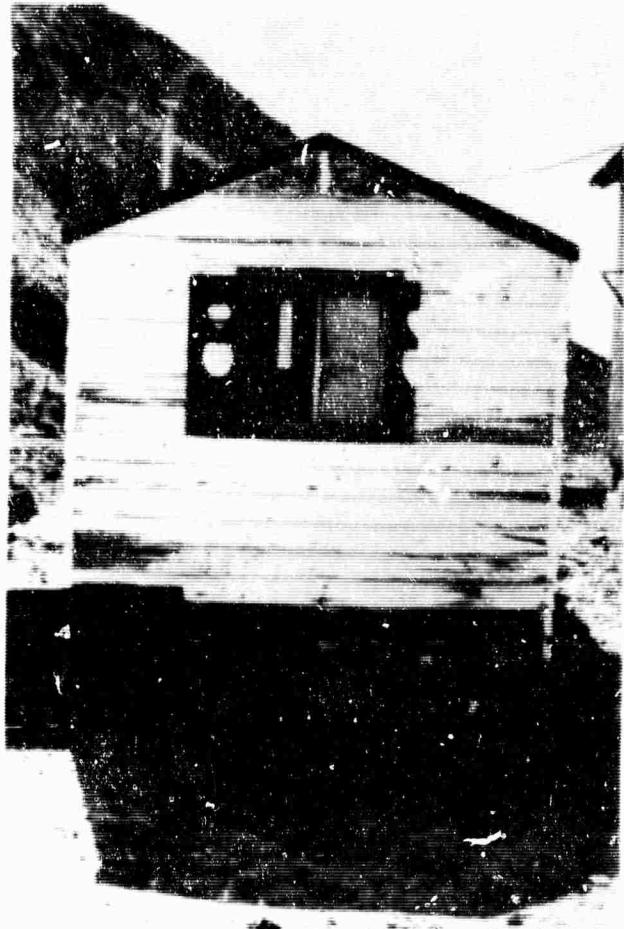
Photo No. 21-35

21-35 Bunkhouse (See photo 21-35) This is a wood frame and siding 6 x 15-foot bunkhouse. AZ 145° clockwise from magnetic north. No damage was noted as a result of the postshot survey.

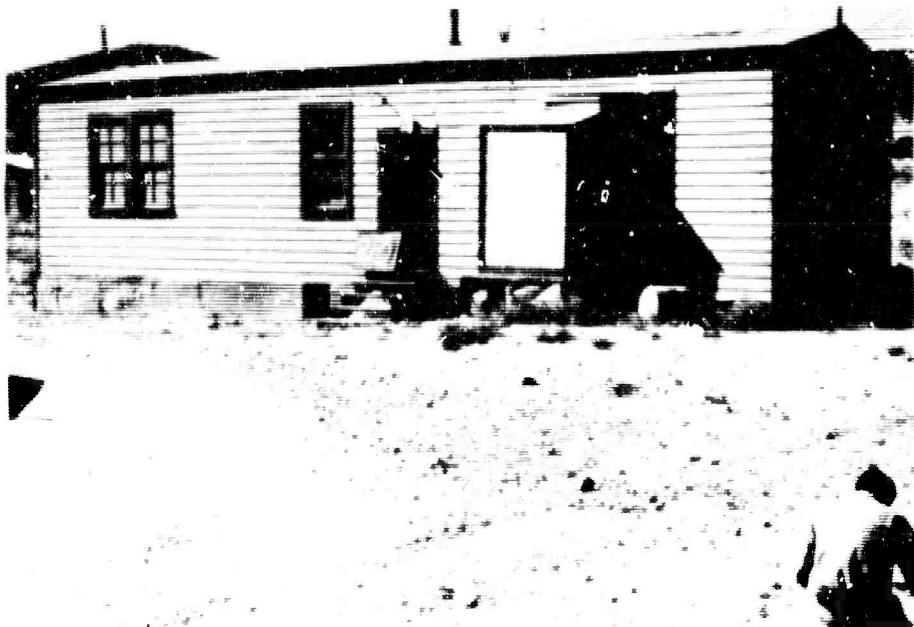
Photo No. 21-37 - Preshot - October 2, 1963

21-37 Club House (See photo 21-37) This is a 12 x 42-foot wood frame and wood siding club house building. AZ 245° clockwise from magnetic north. No damage was noted as a result of the postshot survey.

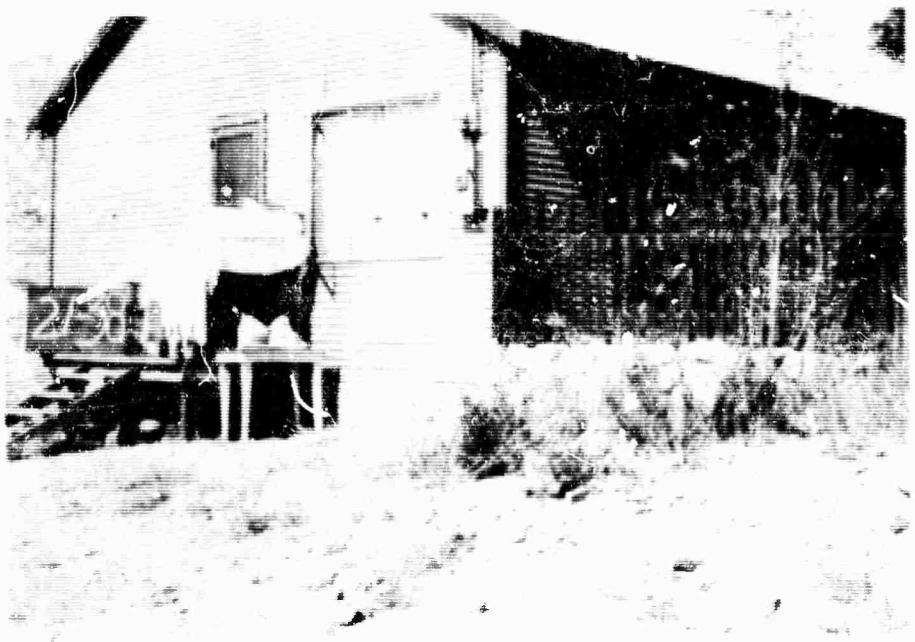
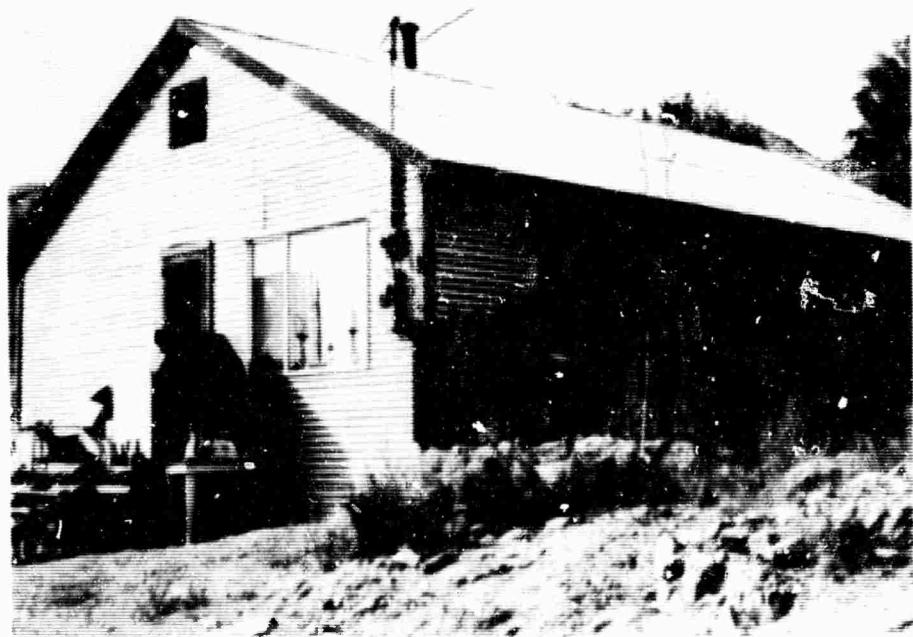
Photo No. 21-38 - Preshot - October 2, 1963

21-38 Residence (See photo 21-38) This is a 21 x 30-foot residence of wood frame with corrugated metal siding. AZ 330° clockwise from magnetic north. No damage was noted as a result of the postshot survey.

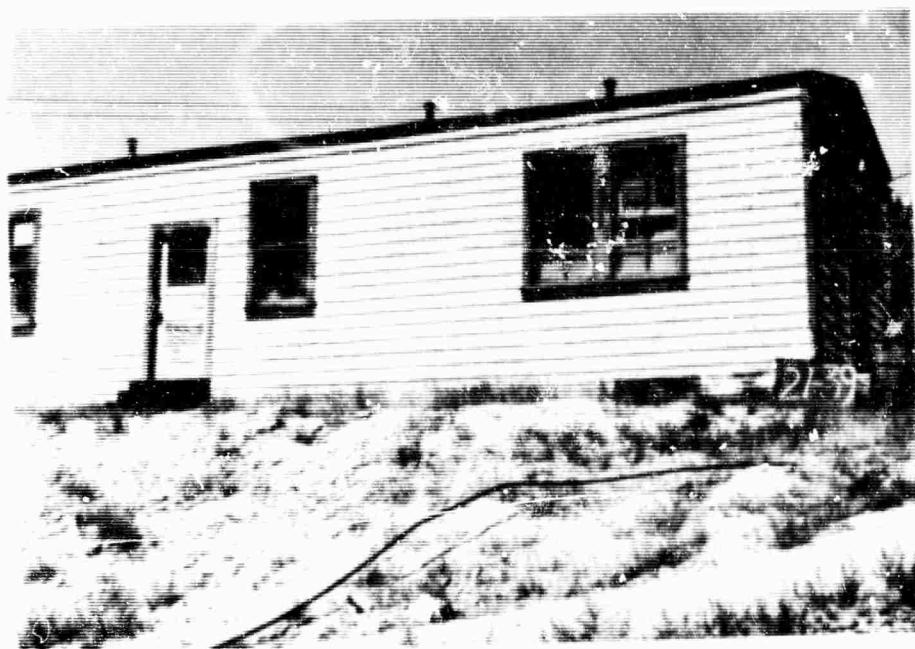
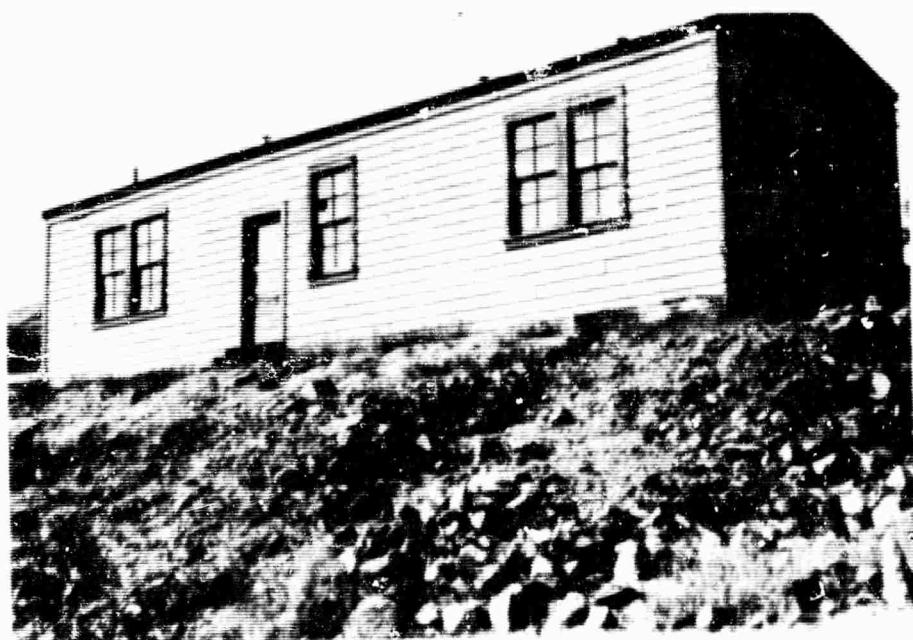
Photo No. 21-39 - Preshot - October 2, 1963

21-39 Storehouse (See photo 21-39) This is a 21 x 42-foot wood frame and wood siding storehouse. AZ 230° clockwise from magnetic north. No damage was noted as a result of the post-shot survey.

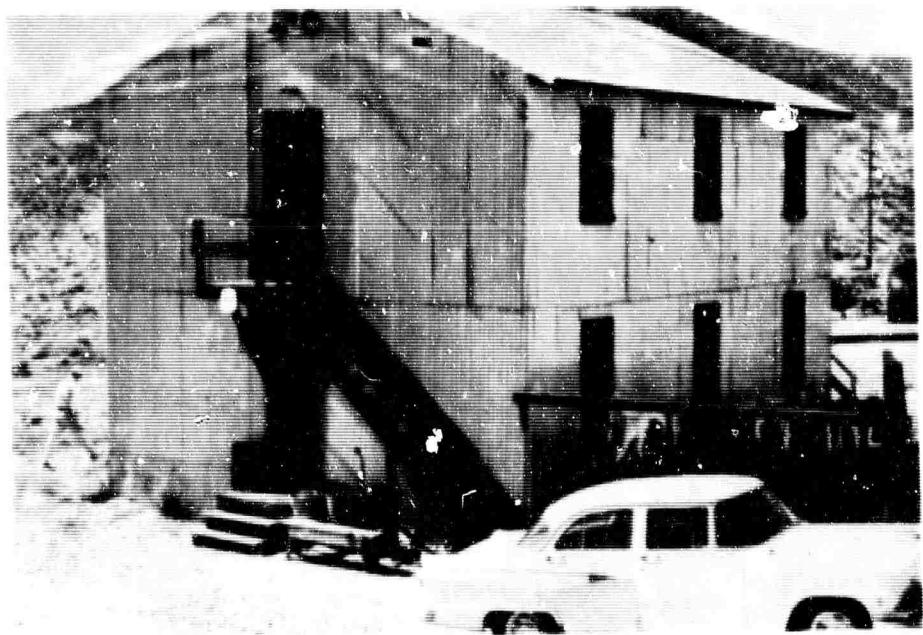
Photo No. 21-40 - Preshot - October 2, 1963

21-40 Bunkhouse (See photo 21-40) This is a 27 x 30-foot bunkhouse of wood frame with corrugated metal siding. This is a two story structure. AZ 230° clockwise from magnetic north. No damage was noted as a result of the postshot survey.

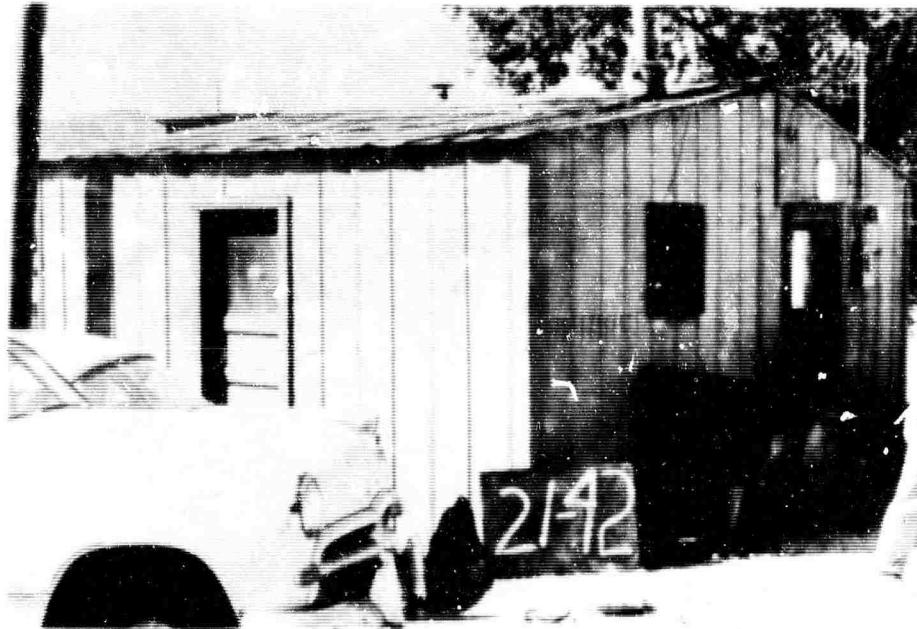
Photo No. 21-42 - Preshot - October 2, 1963

21-42 Residence (See photo 21-42) This is a 15 x 15-foot residence of wood frame and corrugated metal siding. AZ 175° clockwise from magnetic north. No damage was noted as a result of the postshot survey.

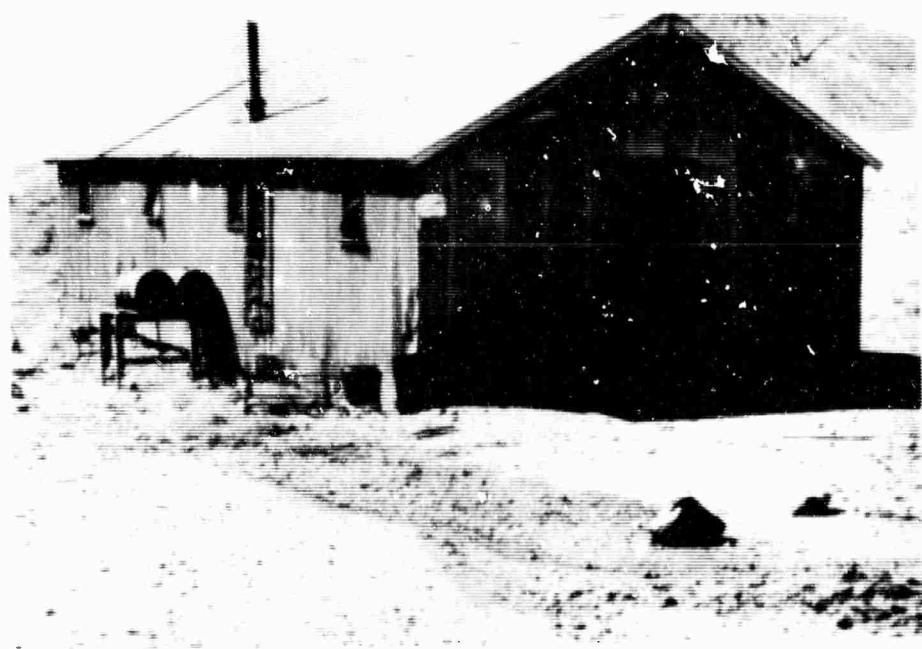
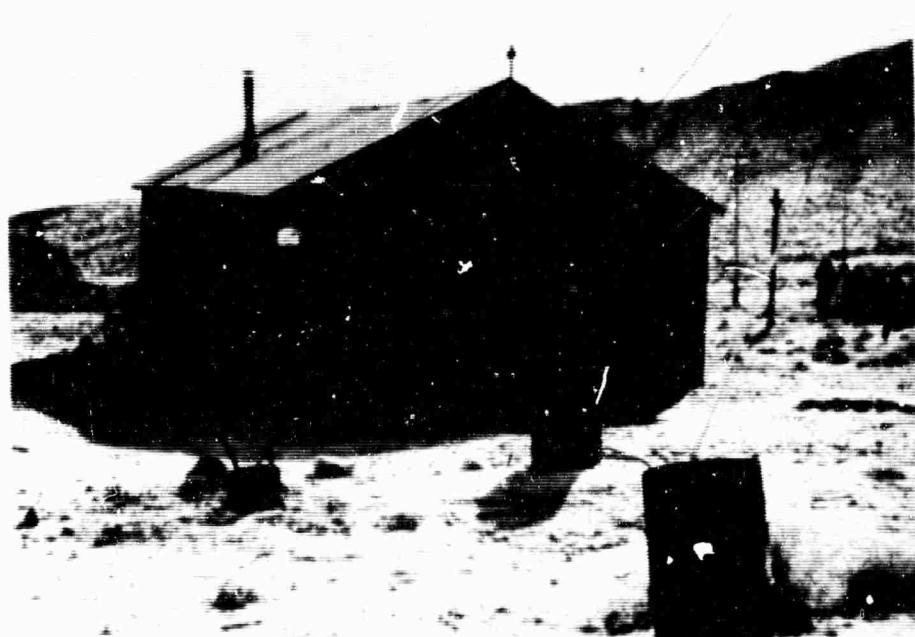
Photo No. 21-43 - Preshot - October 2, 1963

21-43 Residence (See photo 21-43) This is an 18 x 45-foot residence of wood frame and corrugated metal siding. AZ 175° clockwise from magnetic north. No damage was noted as a result of the postshot survey.

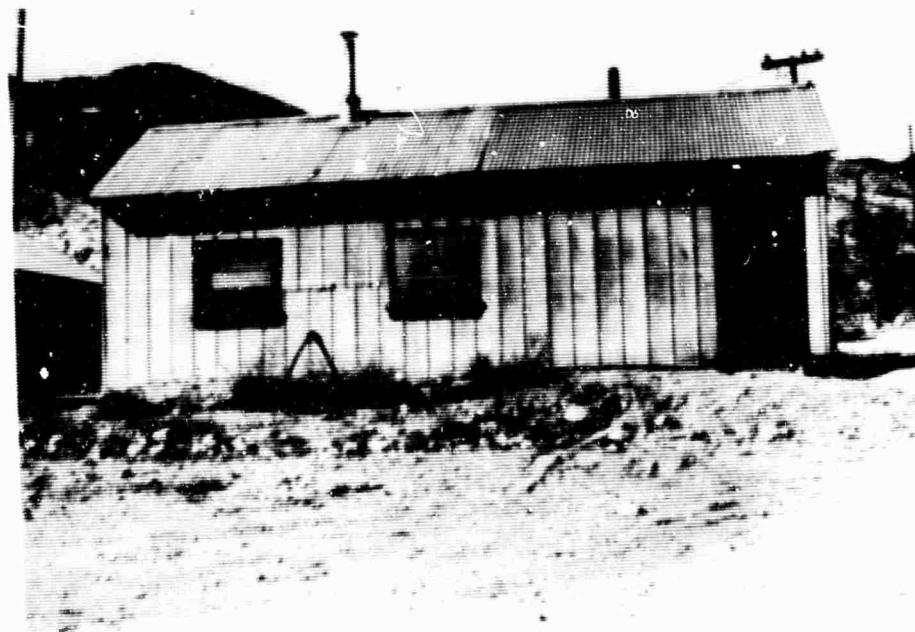
Photo No. 21-44 - Preshot - October 2, 1963

21-44 Storehouse (See photo 21-44) This is a 14 x 27-foot wood frame and corrugated metal storehouse. AZ 345° clockwise from magnetic north. No damage was noted as a result of the postshot survey.
